**Flood Control Project Maintenance
Levee Inspections**

Maintenance Issue Types Only, Levee Inspection Report By Mile - Fall 2018

Reclamation District No. 1500 Sutter Basin

Waterway	Bank	Unit Miles	Inspection Start/End	Inspector
Unit No. 01 Sacramento River	Left	33.15	10/16/2018 10/18/2018	Zach Jojola

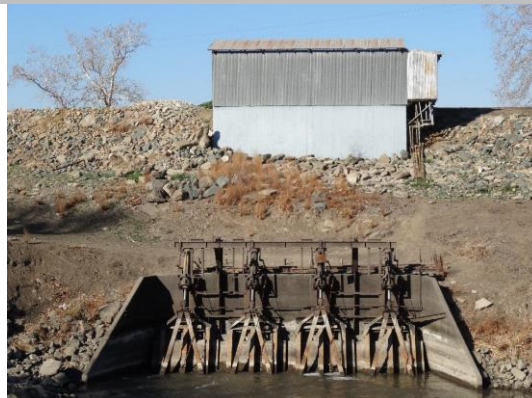
Photo 1 of 3 : UCIP_FA_2018_28886_53098.jpg

Comment Code					
Inspector Comment					
FS_ID:28886 DS_ID:20020 EP_NO: N/A Repair Type: No Action Needed Crossing Status: Found UCIP Comments: Pumping plat was working during the field visit.Hydraulic gates on outfall structure. Motorized slide gates on waterside shoulder. FIELD_STRUCT_DESC: [Reclamation District No. 1500, Pumping Plant No. 3] 1 of 4: 72-inch by 84-inch reinforced concrete box drainage discharge conduit under the levee, 35 feet below the crown. Two concrete cutoff walls. Pumps in concrete pumping plant on the landside (LS). Timber steps on the LS slope. Two service poles and anchors on the LS shoulder. Electrical control gates in a metal and concrete building on the waterside (WS) shoulder. Flap gates on the WS end. Installed by USACE in 1950. (Construction of a four compartment concrete gravity outlet conduit under the levee authorized under Permit No. 1284, 1948 - Reclamation District No. 1500). [Additional Reference(s): DWR Levee Log, 1993. USACE Sacramento O&M Manual 129, June 1954, (Station 1227+00)]. FS Date: 1/21/2014

WS view: CM shed for slide gate on levee shoulder (top) and outfall structure at levee toe (bottom).

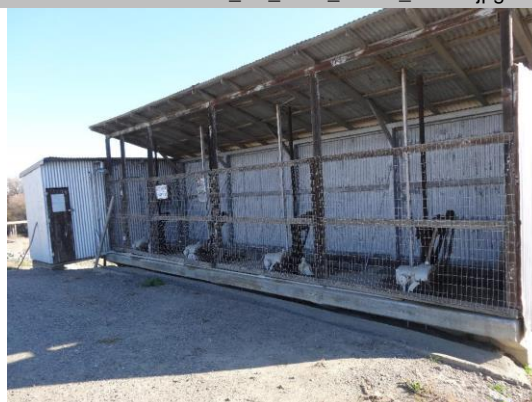
Photo 2 of 3 : UCIP_FA_2018_28883_53083.jpg

WS view: motorized slide gates in CM shed on levee shoulder.

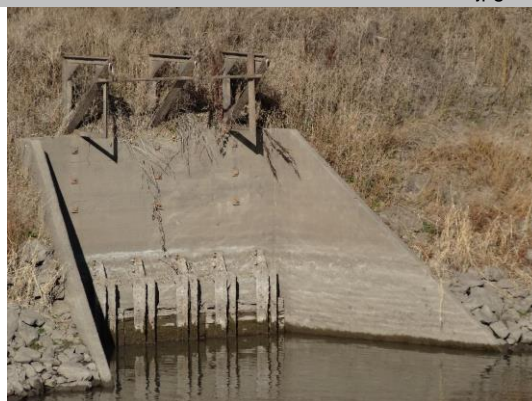
Photo 1 of 3 : UCIP_FA_2018_28955_53265.jpg

Comment Code						
Inspector Comment						
FS_ID:28955 DS_ID:20025 EP_NO: 10088 Repair Type: No Action Needed Crossing Status: Found UCIP Comments: USED Bench Mark on concrete structure at levee shoulder. FIELD_STRUCT_DESC: [Reclamation District No. 1500, Pumping Plant No. 2] 2 of 3: 48-inch by 48-inch reinforced concrete box drainage discharge conduit under the levee, 37 feet below the crown. Two concrete cutoff walls. Pumps in concrete pumping plant on the landside (LS). Slide gates mounted on a concrete structure on the waterside (WS) slope. Discharges in borrow pit. Flap gates on the WS end. (48-inch by 48-inch reinforced concrete box drainage discharge conduit under the levee and all other appurtenances retained under Automatic Board Order (ABO) issued as Permit No. 10088, 1974 - Reclamation District No. 1500). [Additional Reference(s): DWR Levee Log, 1993. USACE Sacramento O&M Manual 129, June 1954, (Station 1226+00)]. FS Date: 1/21/2014

WS view: U type concrete headwall and flap gates on levee toe.

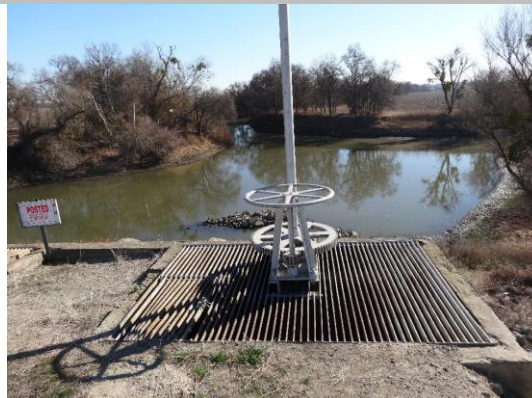
Photo 1 of 3 : UCIP_FA_2018_28891_53137.jpg

WS view: slide gate in concrete box on levee shoulder.

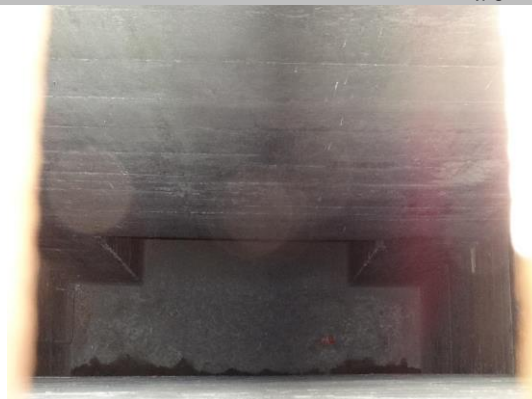
Photo 2 of 3 : UCIP_FA_2018_28891_53136.jpg

WS view: inside view of concrete box on levee shoulder.

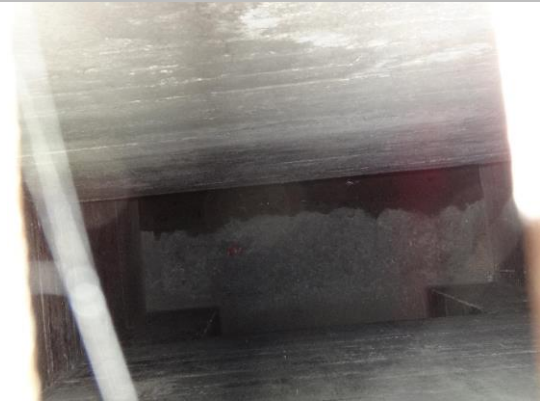
Photo 3 of 3 : UCIP_FA_2018_28892_53145.jpg

WS view: inside view of concrete box on levee shoulder.

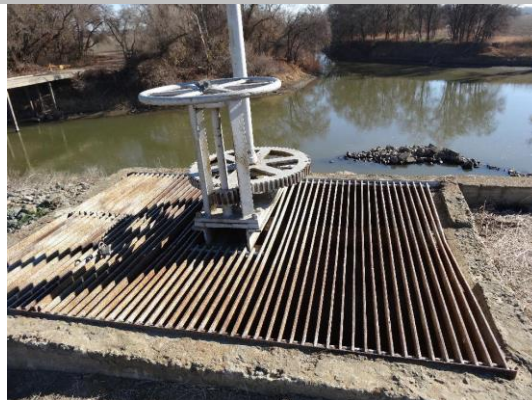
Photo 1 of 3 : UCIP_FA_2018_28893_53157.jpg

WS view: slide gate in concrete box on levee shoulder.

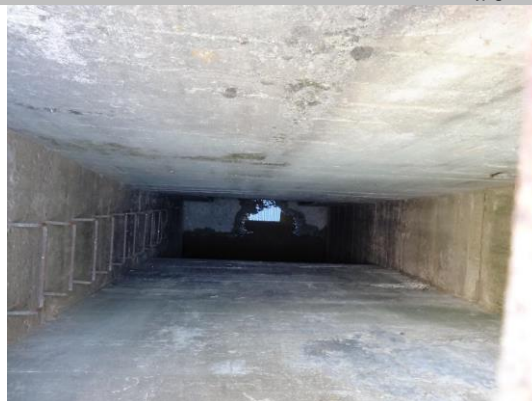
Photo 2 of 3 : UCIP_FA_2018_28893_53156.jpg

WS view: inside view of concrete box on levee shoulder.
